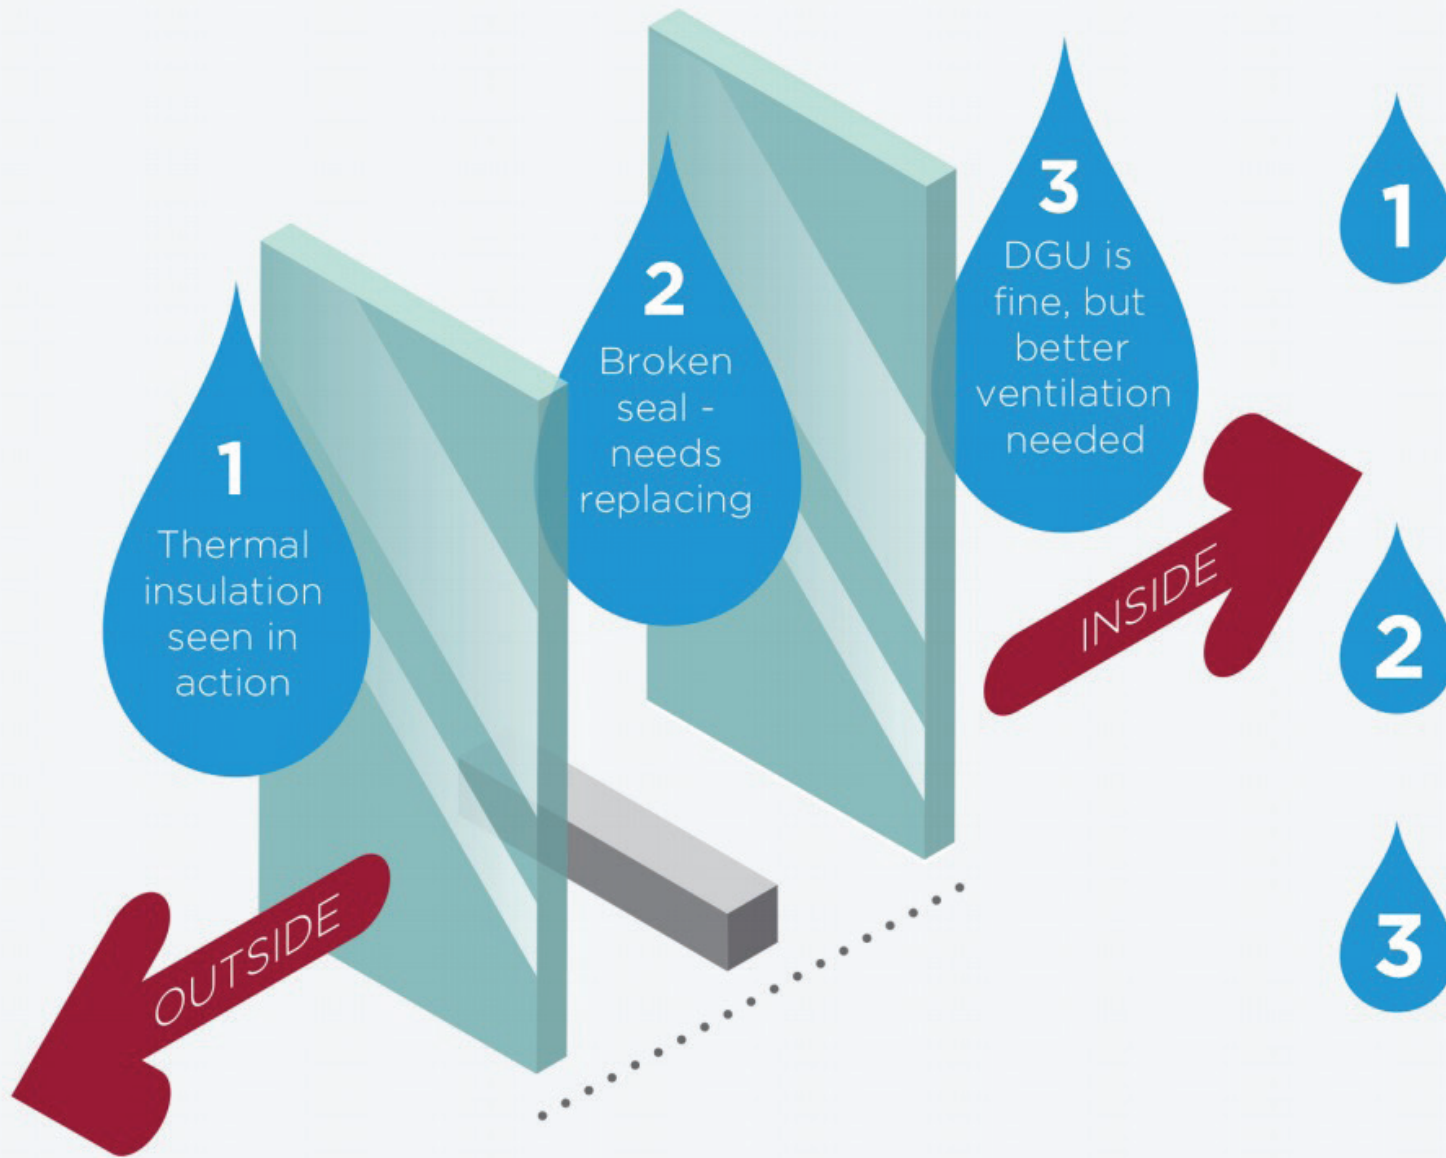
Condensation forming on the outdoor face is a positive indicator that heat is being retained inside the home and the glass is thermally efficient. This is a natural phenomenon and not an IGU fault. (IGU = Insulated Glass Unit)

Condensation inside the cavity indicates the IGU seal has broken down; this is a failure of the IGU.

This is due to warm, moist air being trapped in the building. This indicates a problem with the building itself suggesting that increased air ventilation is required. The condensation on the glass is a symptom and not a sign of a faulty IGU.
